**CITY OF YANKTON**

Subj: Materials & Structural Evaluation of Pool  
Yankton Pool  
Yankton, South Dakota

Ref. No. 05F-15005

**Re:** Yankton Pool Study

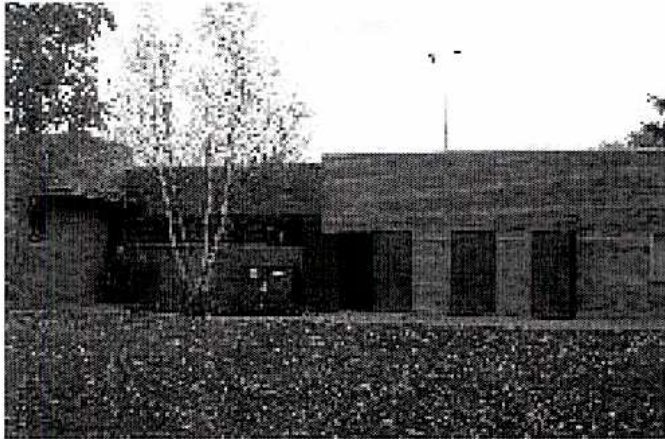
E1

1. This facility is served by a pad mount 112.5 KVA transformer. This transformer sits on the front side of the building. The voltage rating of this transformer is 12,470Y/7200, to 208Y/120 volt, 3 phase. [Picture E1]

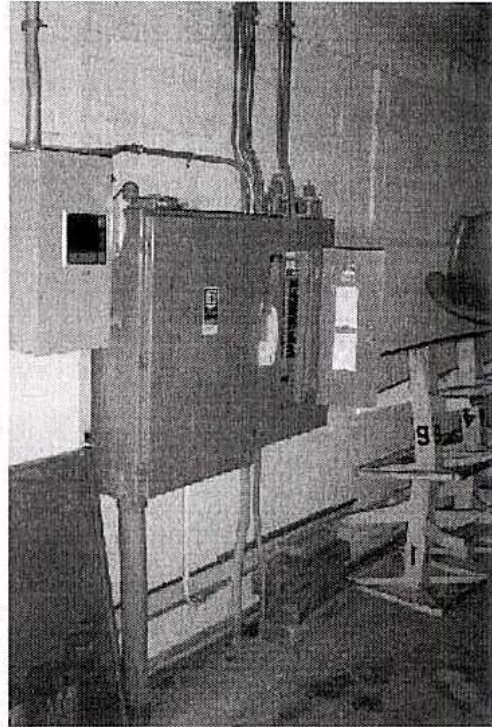
E2

2. A single 3 inch conduit runs between the secondary of this transformer and a 400 amp 240 volt, 3 phase fusible main service disconnect located in the Mechanical Room immediately adjacent to the transformer. [Picture E2]

11. There is an electric gear that served the original building that is located in the basement of the facility this gear had been abandoned. This gear had been severally corroded and had deteriorated. [Picture E2]

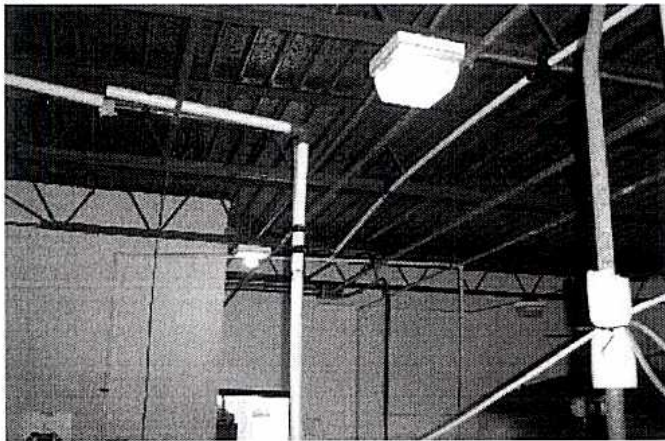
E3

1. Most all interior lighting throughout the facility is done utilizing incandescent light fixtures. This type of lighting, although relatively inexpensive, is high maintenance. [Picture E3]
2. Light fixtures in the Men and Women's Shower areas are open type fixtures with no lens.
3. Light fixtures in the Mechanical Room are the lensed type. However, the lenses are missing on several of the fixtures.
4. Light fixtures that have been painted do not show signs of corrosion on the painted portion of the fixture. However, any unpainted portions of the fixtures are showing signs of corrosion. [Picture E4]
5. Lighting in the basement of the facility is done with a mixture of different types of incandescent lighting. This is in very poor condition.
6. Lighting levels within the building are inadequate.

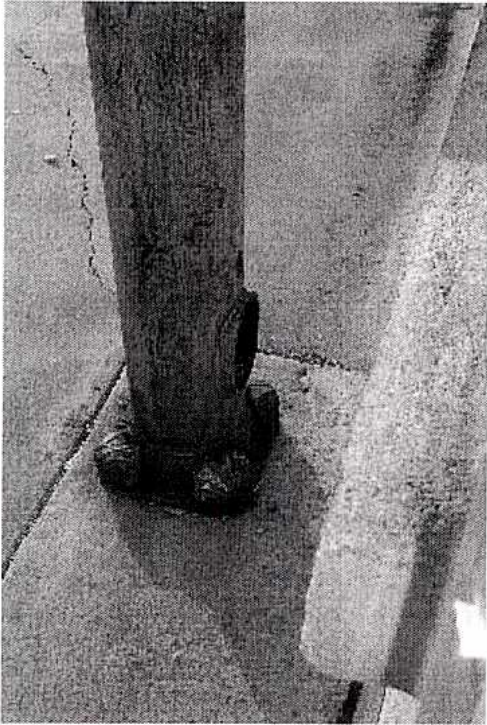
E8

7. It appears that the fixtures located at the top of the poles are high wattage quartz floodlights. [Picture E7]
8. The poles are showing signs of corrosion through out their entire length. It appears as if they have been painted at least once in the past. However, rust is showing through. [Picture E8]

8. There is a junction box cover not installed located at the bottom of one of the light poles that serves the pool area. Presently it would be possible for any one of the general public to reach in to the pole and grab electrical wires. This is exposing the general public to a potential electrical shock hazard. [Picture E8]

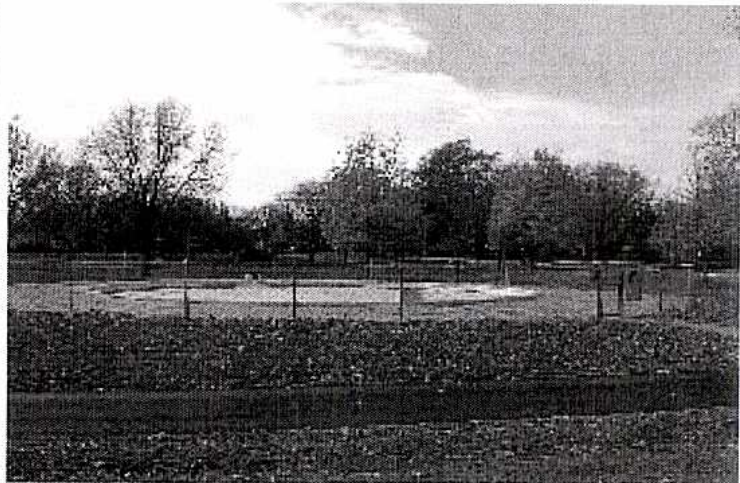
E9

14. Presently there does not appear to be any lighting in the small wading pool area located immediately to the South of the main pool. [Picture E9][

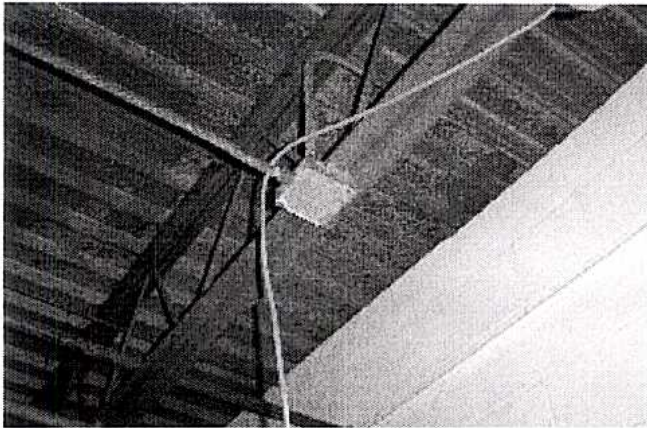
E10

1. Much of the conduit in the facility is showing signs of corrosion depending upon its location. This corrosion ranges from moderate to very severe. [Picture E10]

9. There is not a fire alarm present in the building.
10. The phone service to the building appears to come in on the North side of the building.
11. Electrical conduit support devices all appear to be metal. These supports show varying degrees of corrosion from moderate to severe. [Picture E10]

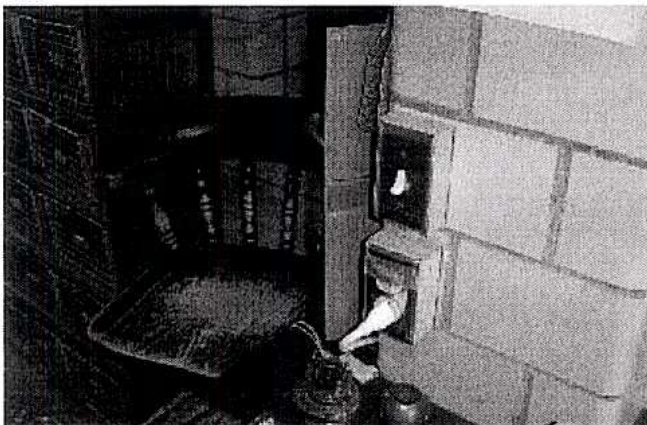
E11

5. There do not appear to be any GFI protected convenience receptacles located at the pool deck area as is required by the National Electric Code.
6. There is a metal j-box with broken PVC conduit running up into the bottom of it at the pool deck. This situation is exposed to the general public and provides a potential risk of shock. [Picture E11]

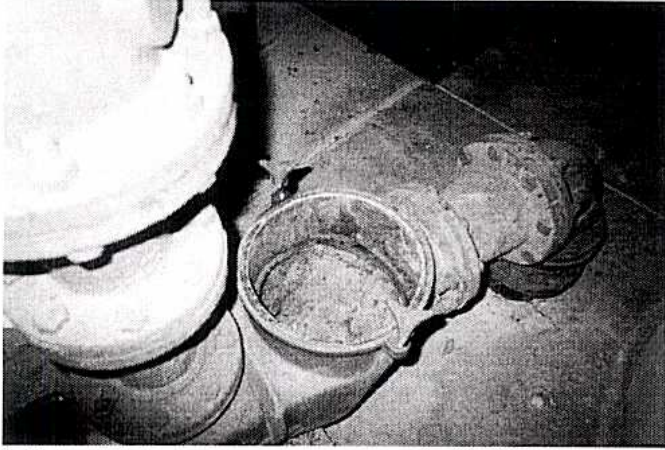
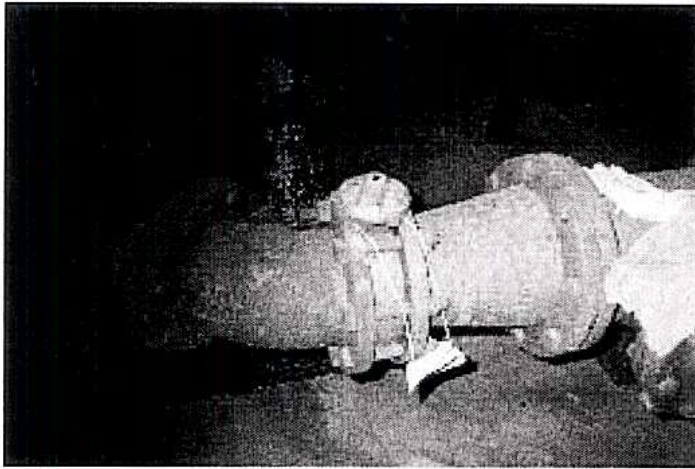
The pumps were new in the 1970's and are too small to provide the required water exchanges per day and are recommended to be replaced. (Per 10 state code) Some of the piping associated with the pumps is degraded, full of scale and at least one (1) valve does not operate and is therefore recommended to be replaced. [Pictures M1 & M2].

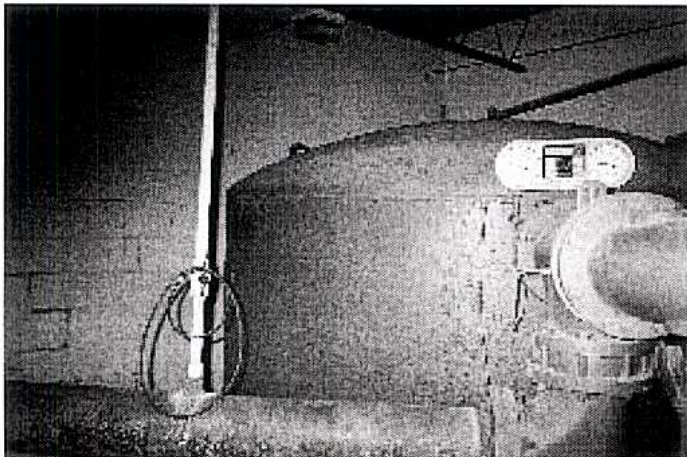
M3

The sand filters show rust on the outside [Picture M3] but one option is to renovate them.

The interior condition at the filters are unknown. Opinion of probable cost of replacing the pool circulation pumps, related piping, renovating the filters, and replacing chemical feed system is \$70,000.00.

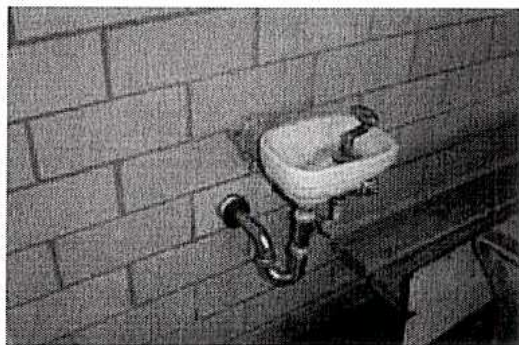
M7

There is one (1) drinking fountain in each of the Men and Women's Shower Room. It is unsightly degraded and does not meet ADA. [Picture M7]
