**Memorandum No. 07-175**

**TO: City Commissioners**  
**FROM: City Manager Jeff Weldon**  
**RE: Continued discussion of Memorial Pool expansion**  
**DATE: August 8, 2007**

## CITY OF YANKTON SD WADER INSPECTION

## CITY OF YANKTON SD POOL LEAK DETECTION

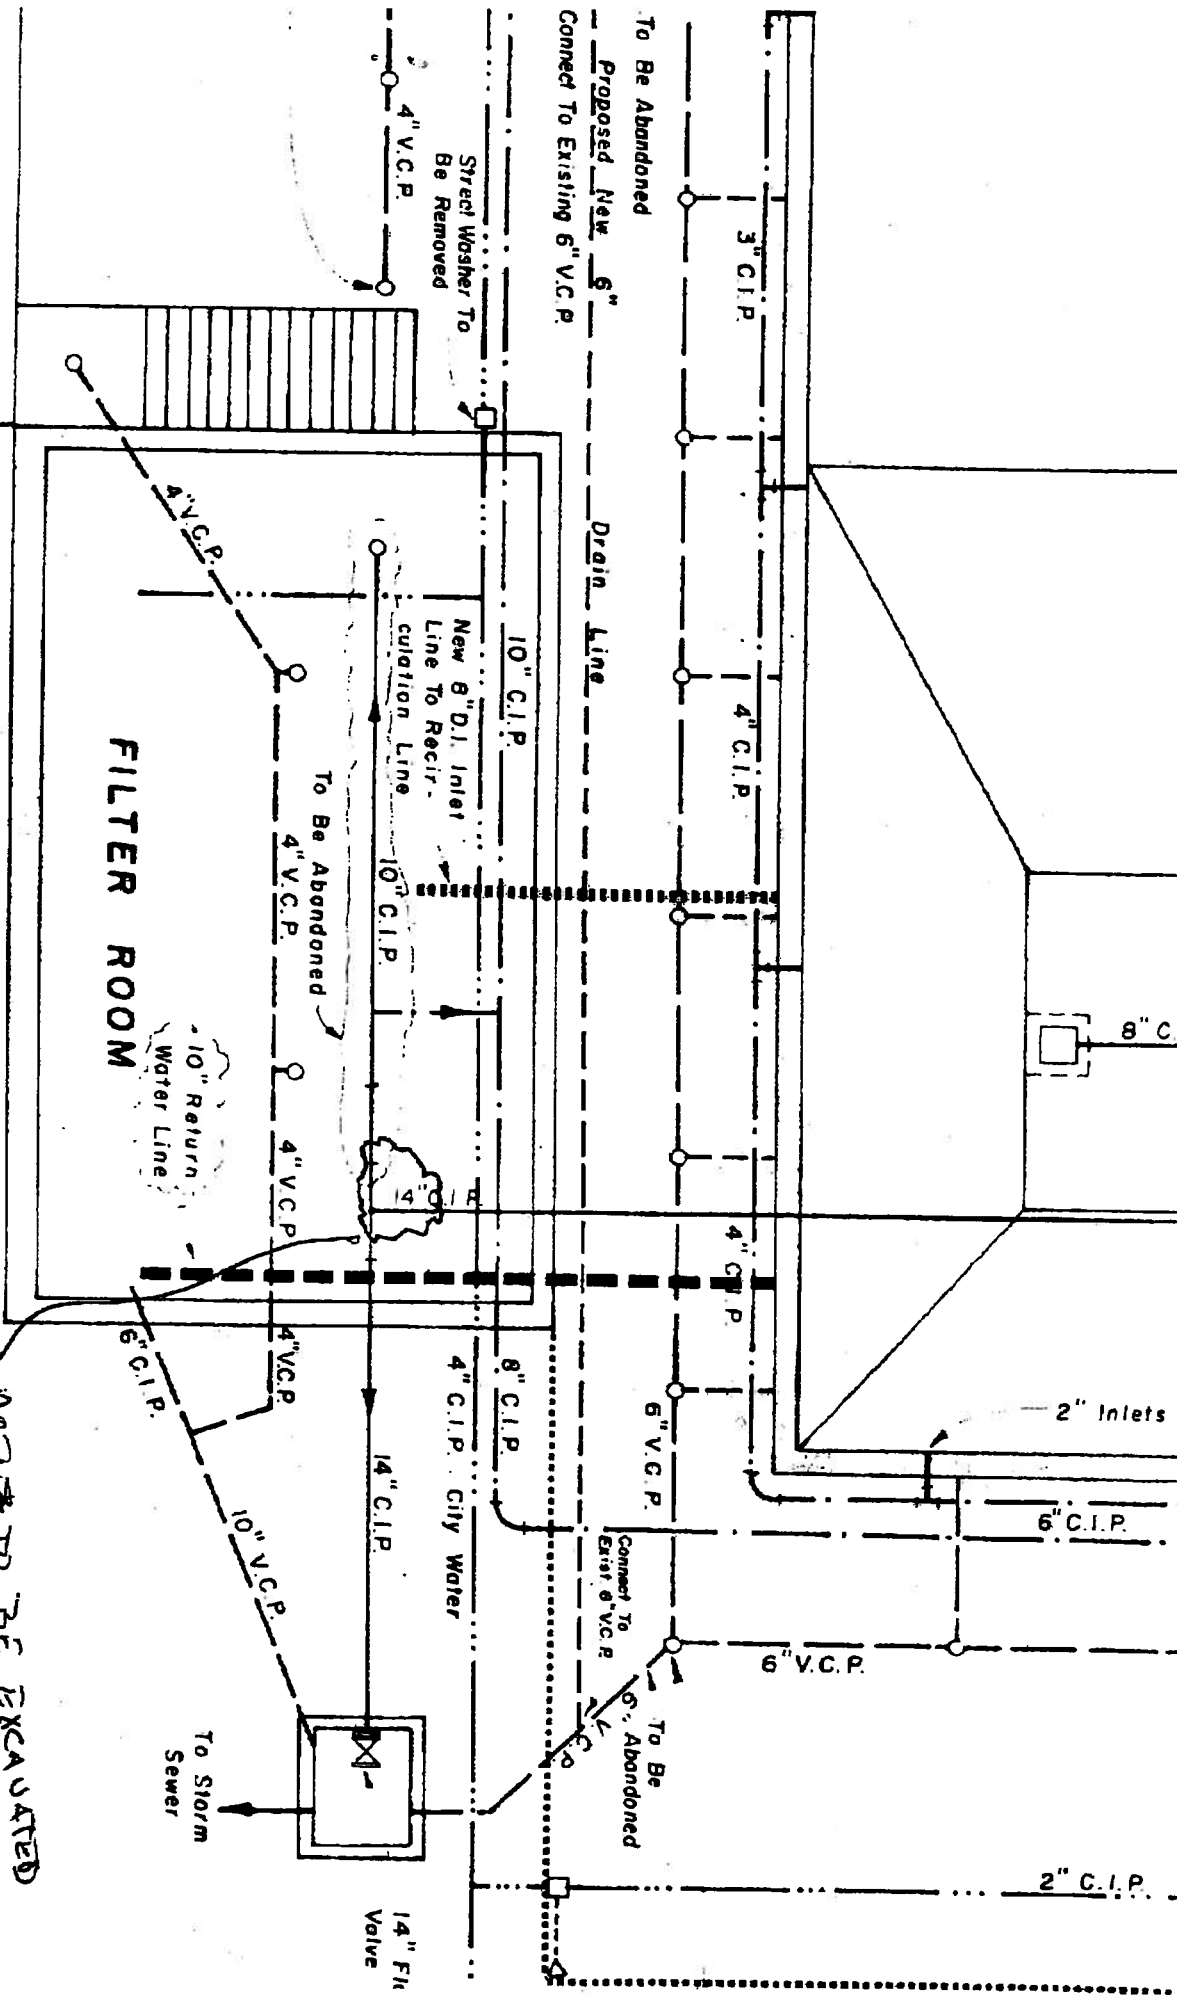
MEMORIAL POOL  
1977 RENOV PLANS

MC&R suggested digging a hole in the basement next to the sump pump to try to find out which direction the water was coming from. Renovation plans in 1977 show there is a 14" tee fitting in close proximity of the sump pit. If this is excavated we may find a 14" tee fitting that was plugged off that could be leaking. City would consider this.

AREA TO BE EXCAVATED  
AND EXAMINED

1. Pump out sump pit and keep area dewatering
2. Excavate area next to sump pit to locate 14" tee fitting and to try to determine direction of water flow.  
Approx. area 4' x 4' x 4' deep. Check for water flow direction and potential leaks on 14" tee
